Please note: this is a draft document – it has not been validated. If you choose to use it please check all steps and, if you find something wrong or have suggestions, contact Rob Mueller. This was presented at the Spring 2016 GMCWS rally at Temecula, CA. Last updated on 5/5/2016

STEERING COLUMN, LOWER STEERING SHAFT, AND STEERING GEAR BOX ALIGNMENT

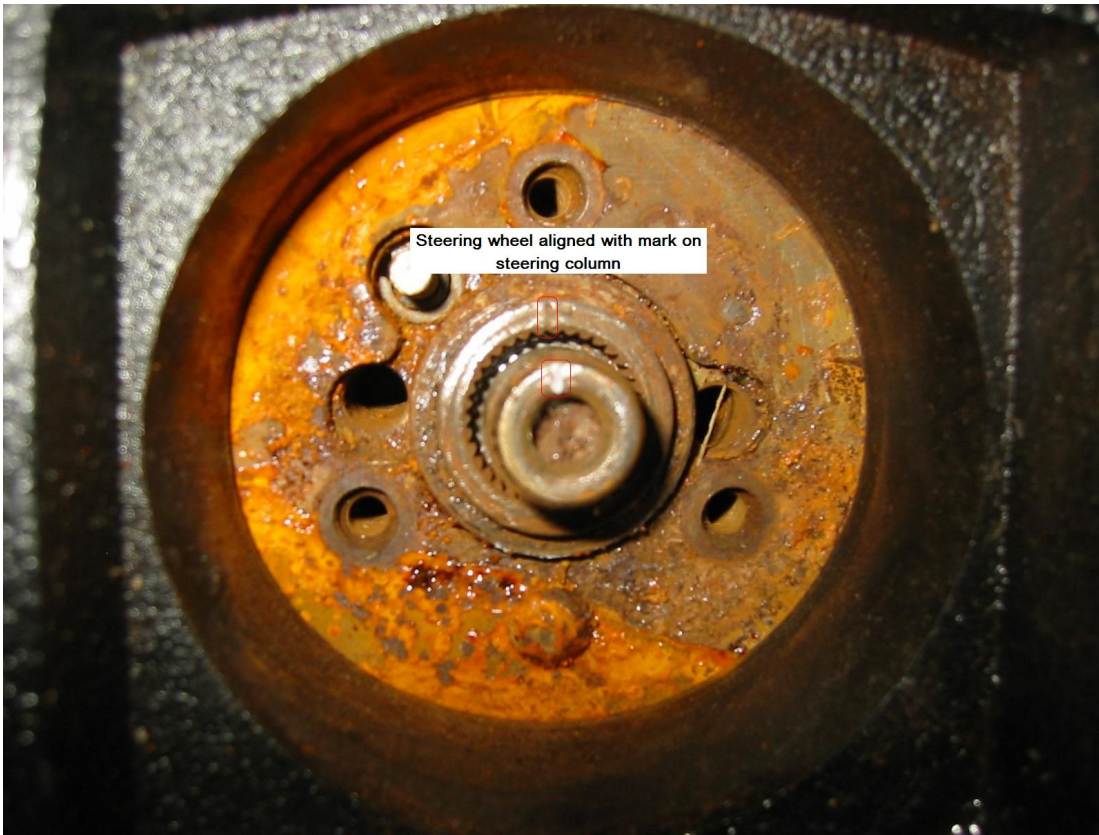
Figure 1 – Steering wheel / column alignment

Once you have determined that the steering gear box is serviceable and adjusted as per the MM remove the horn and the nut that retains the steering wheel. Verify that the marks on the steering wheel and steering column align as per the photo below. If the marks are not aligned remove the steering wheel and re-install it with the marks aligned. Install the retaining nut finger tight.

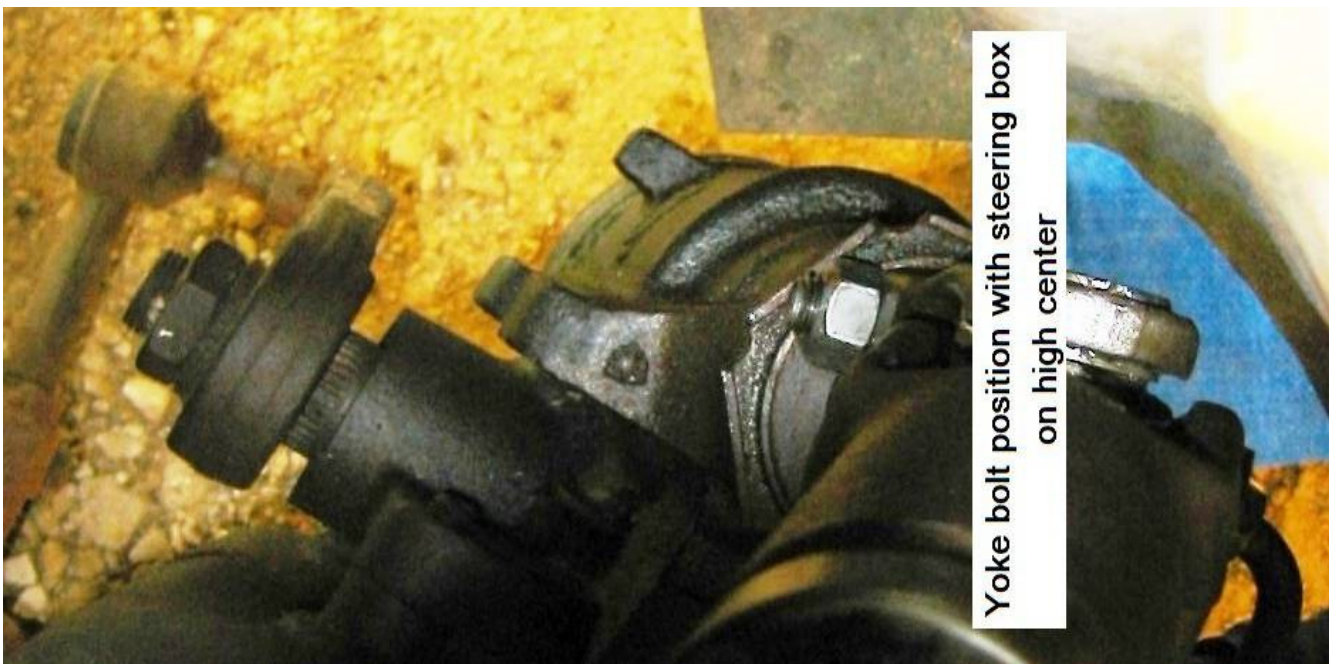
Figure 2 – Yoke bolt position

Orient the steering wheel so that the horizontal supports are 90° perpendicular to the fore / aft axis of your GMC. Open the driver side hood and look down at the lower steering column yoke. If the steering box is on "high center" you should see the following:

If the yoke bolt or drill bit is not as pictured above or the 29/64ths inch drill won't go through the bolt hole indicates that the steering column, lower steering shaft, and steering box input spline alignment is not correct and needs to be aligned. The following procedure will accomplish that task.

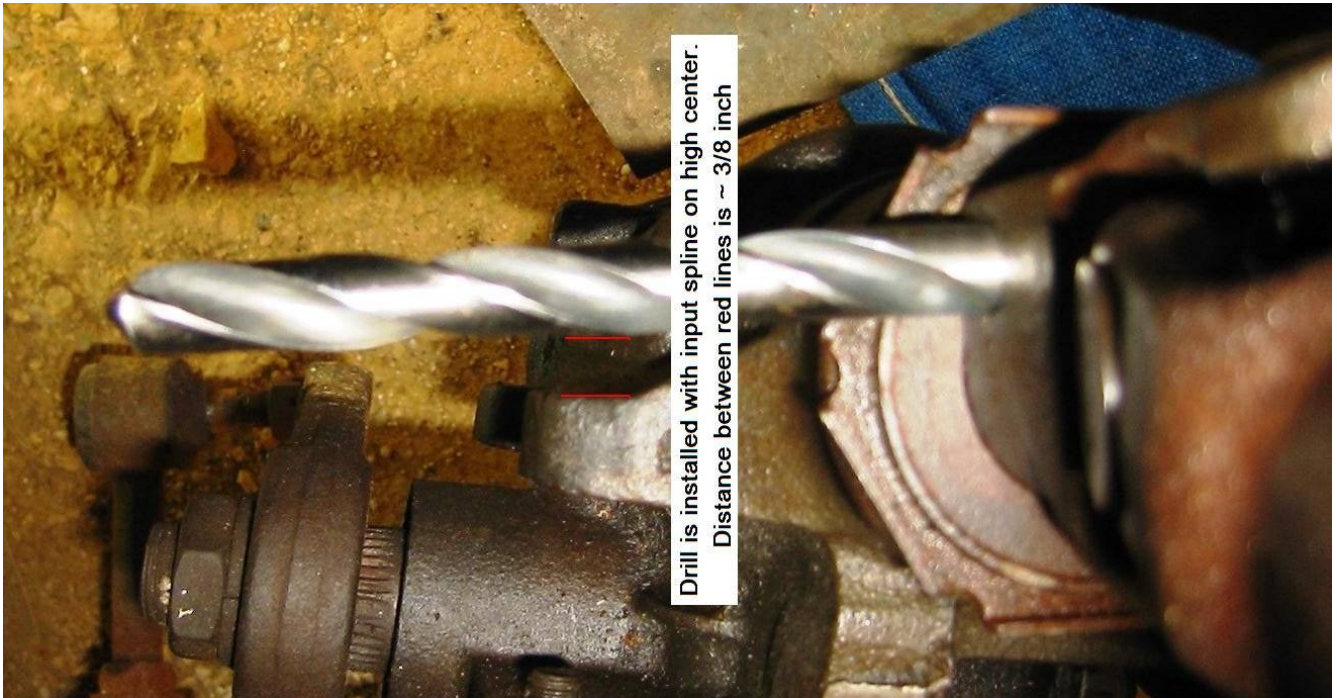
Figure 3 – Yoke bolt position – 29/64ths drill installed

If you're not sure remove the Yoke (10) bolt and insert the shank end of a 29/64 inch drill in the bolt hole and you should see this:

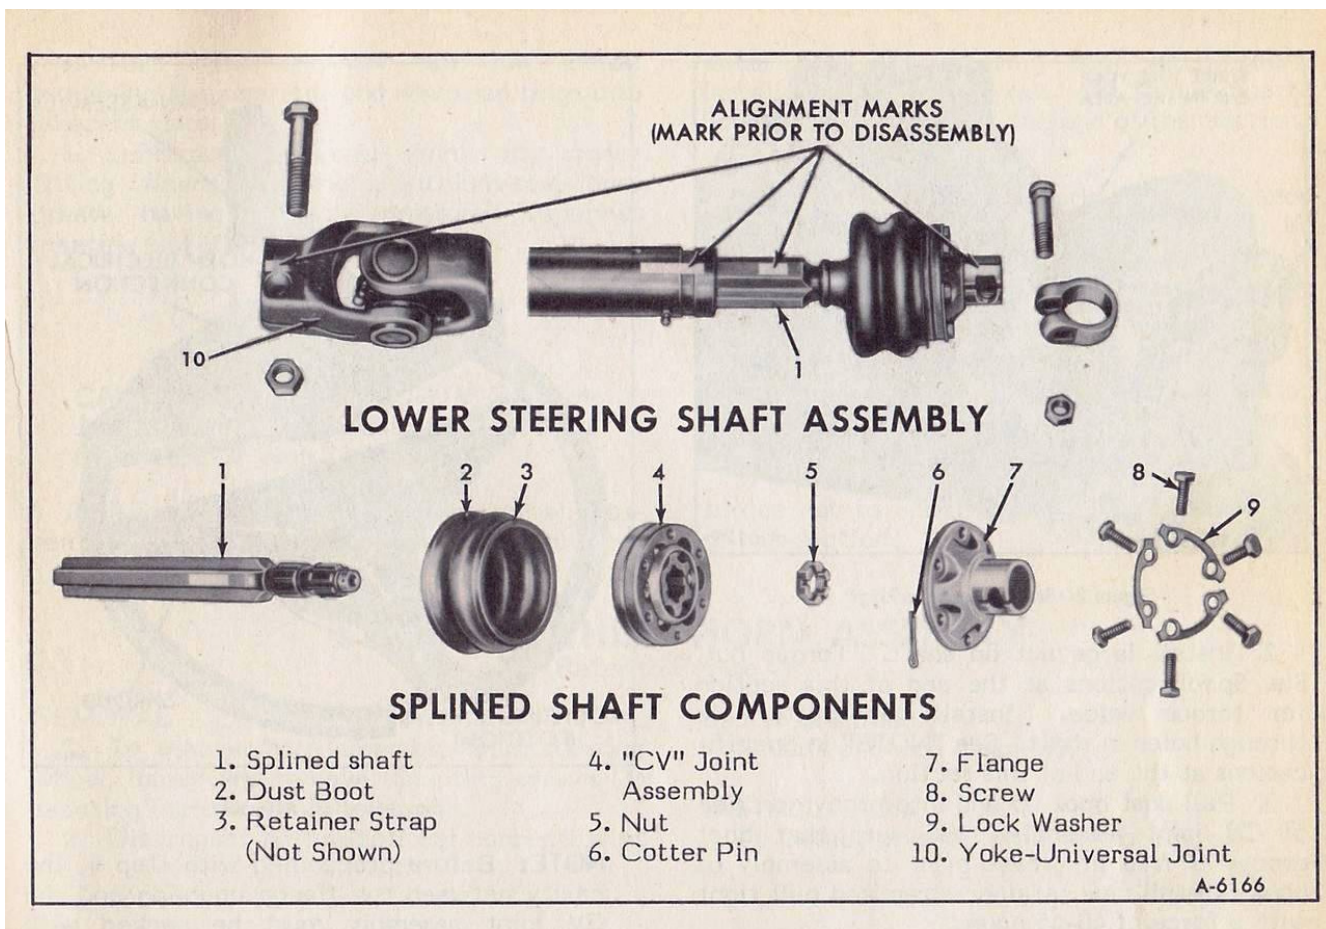
Using the figure below as a reference remove the Lower Steering Shaft

- 1) Remove the lower steering shaft CV joint Flange (7) from the bottom of the steering column.
- 2) Remove the lower steering shaft Yoke (10) from the steering gear input shaft.

- 3) Remove the lower steering shaft from the GMC being careful to hold it horizontally (if you hold it vertically the two parts could separate) and either the Splined Shaft (1) or Yoke (10) could fall on the ground and be damaged or contaminated with dirt (guess how I discovered that)! 😊

- 4) Carefully inspect the lower steering shaft to verify that:
 - a. the "CV" Joint (4) swivels easily and does not have excessive play
 - b. the blue splined shaft (1) moves in and out of the Yoke (10) easily and does not have excessive play

- c. the universal joint swivels easily and does not have excessive play
 - d. remove the Retainer Strap (3) from Dust Boot (2) and peel it back far enough to verify that the "CV" Joint (4) is lubricated with (black) molybdenum grease

Reference Page 3 Figure 4 – Lower steering shaft assembly from MM X-7625

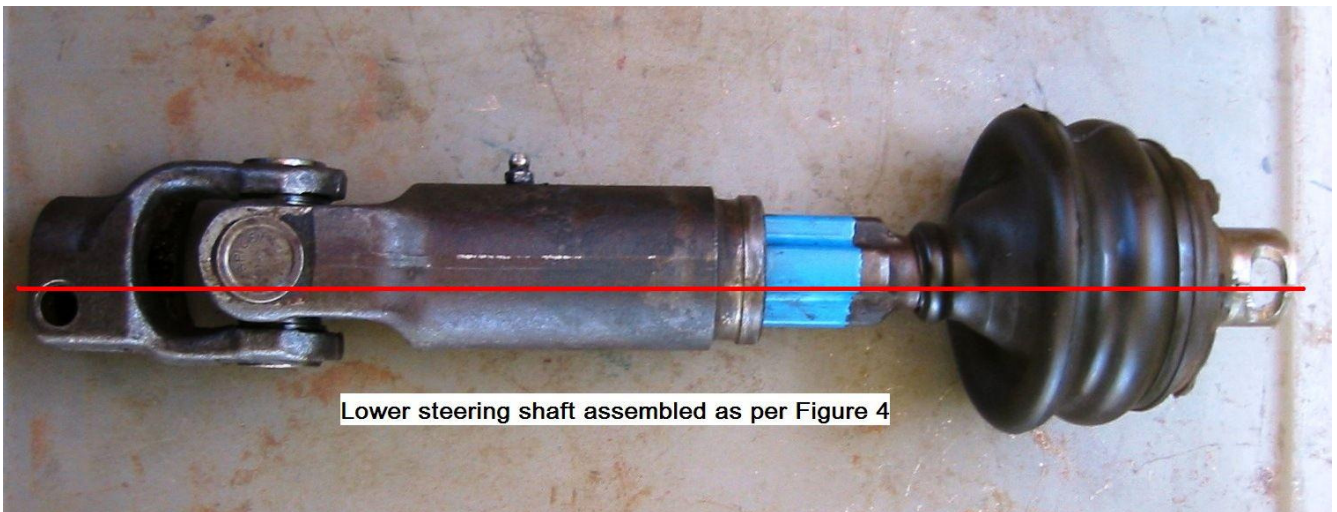
Figure 5 – Lower steering shaft assembly

- e. draw an imaginary line from the split in the Flange (7) to the Yoke (10). The lines relationship to the parts of the lower steering shaft should closely resemble Figure 5 below

If any of the conditions in step 4) above are not met the lower steering shaft must be attended to before alignment can proceed. See Addendum A – Lower Steering Shaft

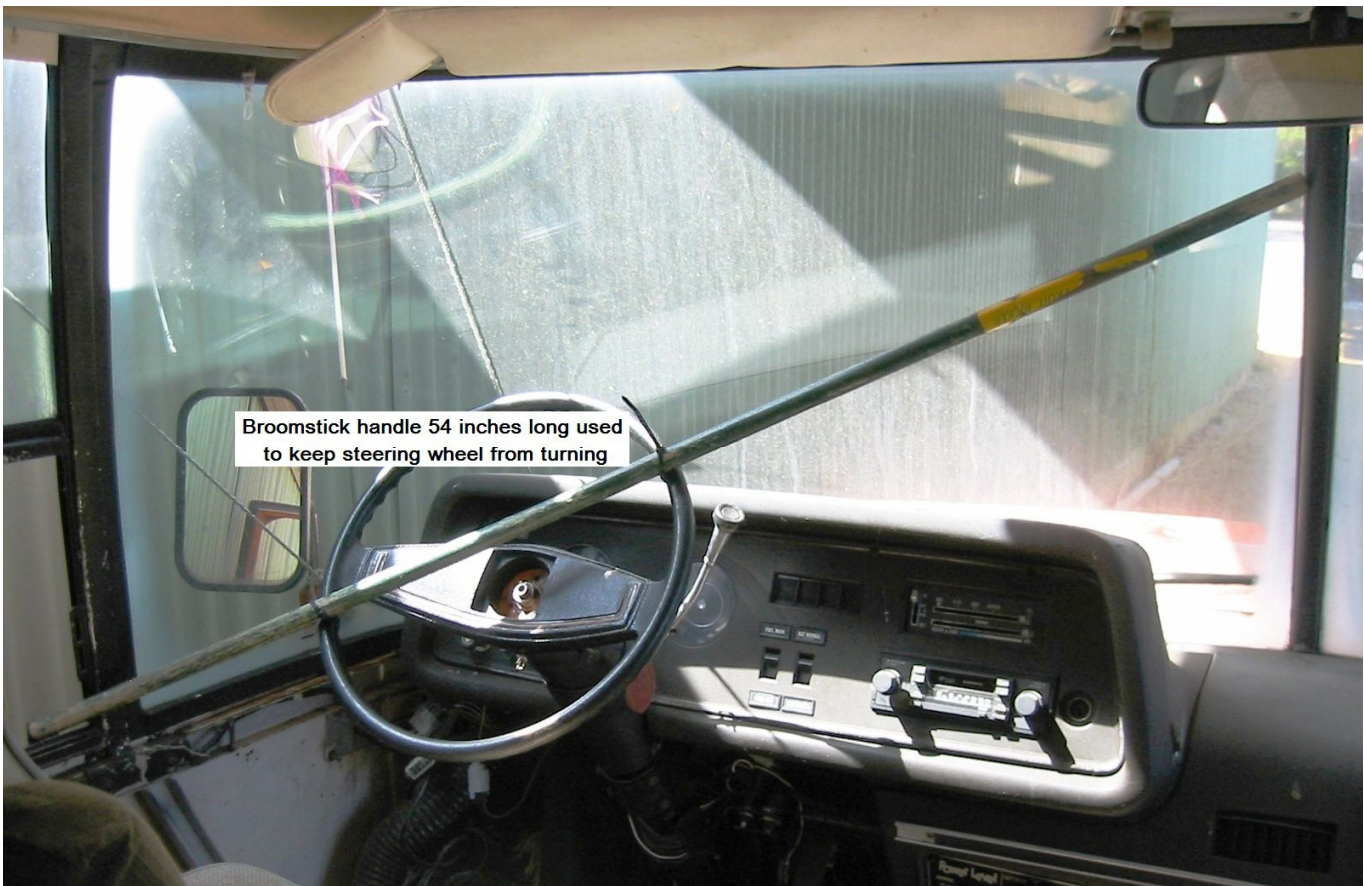
Figure 6A – Broomstick installed to keep steering wheel from turning

- 5) Remove the drag link from the pitman arm. This will keep the knuckle stops from inhibiting steering gear box full travel.
- 6) Orient the steering wheel so that the horizontal spokes are 90° perpendicular to the fore / aft axis of the GMC as they would be driving straight down the road.
- 7) Tie wrap a broomstick to the steering wheel as pictured below.

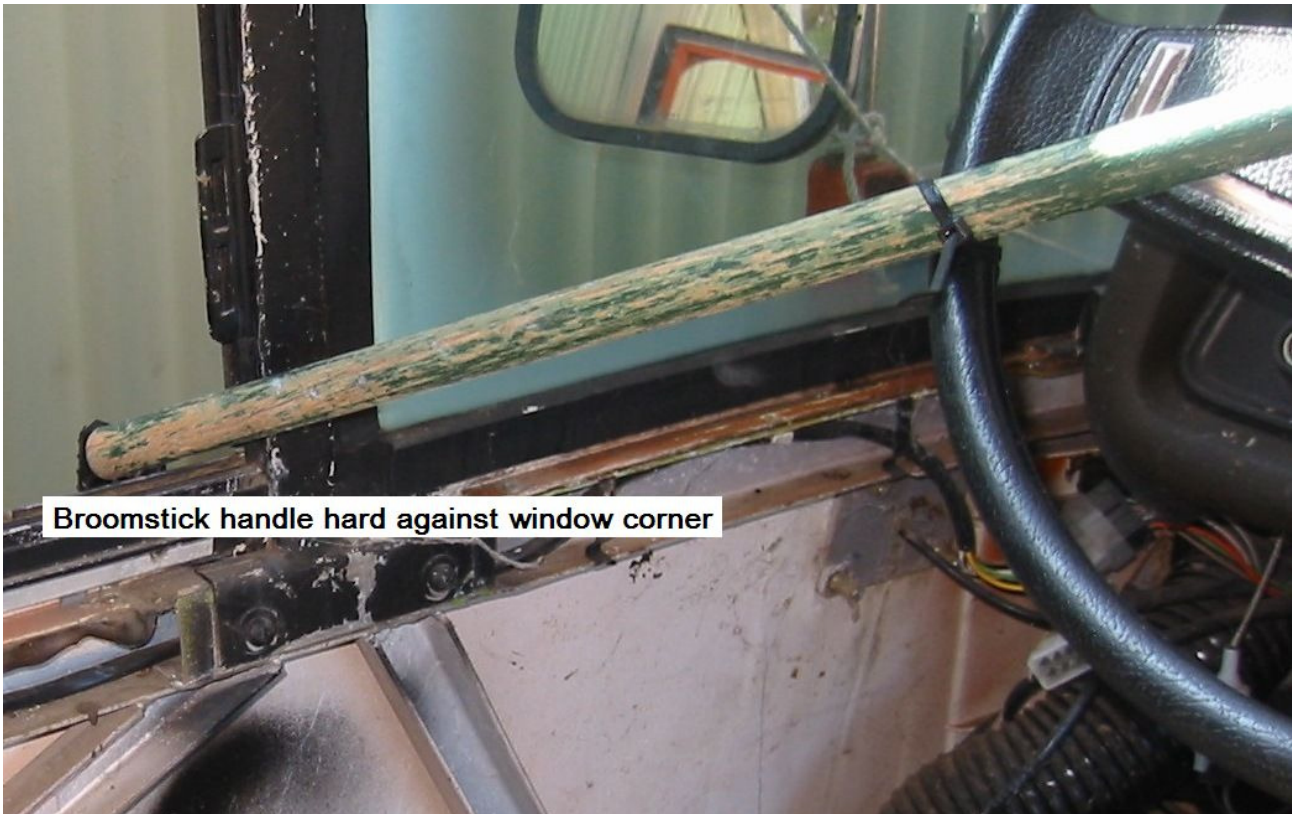
Figure 6B – Broomstick installed to keep steering wheel from turning

Broomstick handle hard against window corner

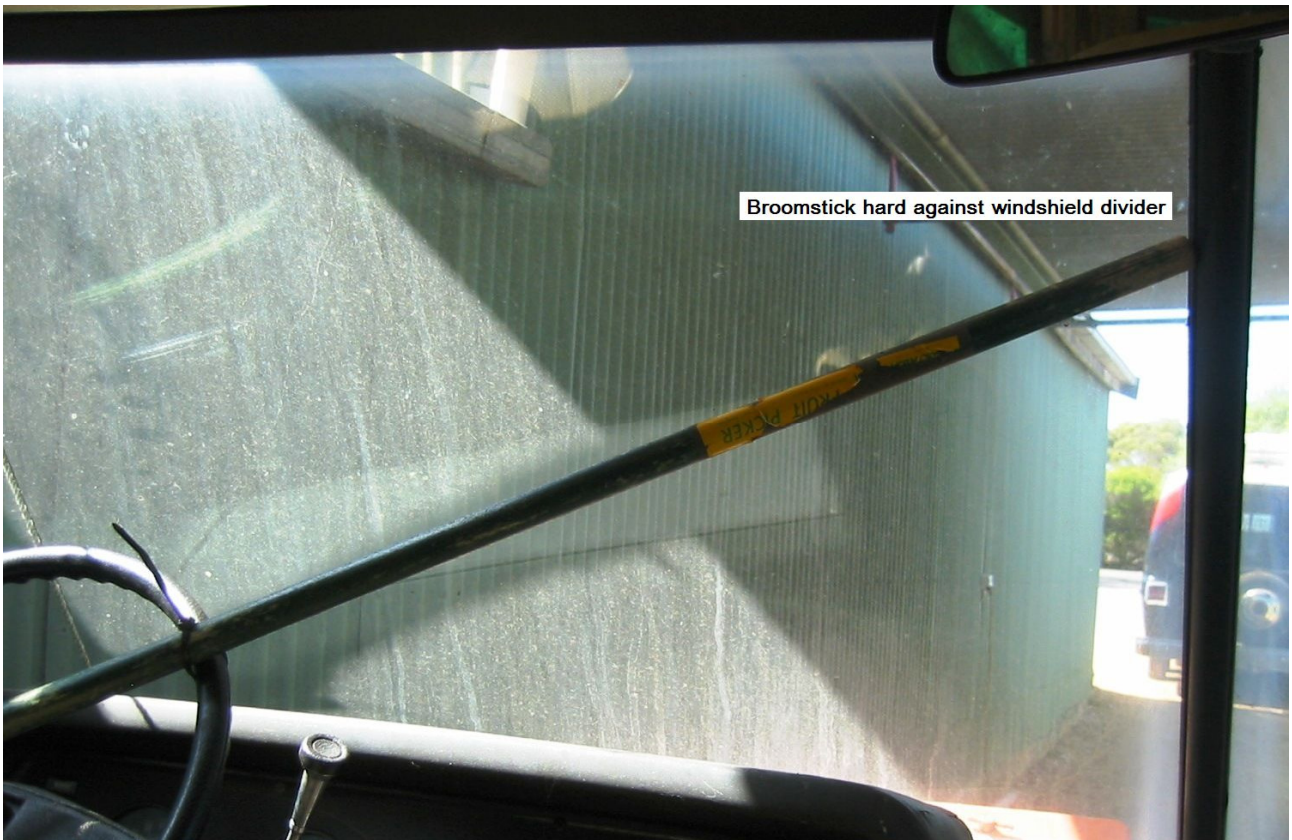
Figure 6C – Broomstick installed to keep steering wheel from turning

Broomstick hard against windshield divider

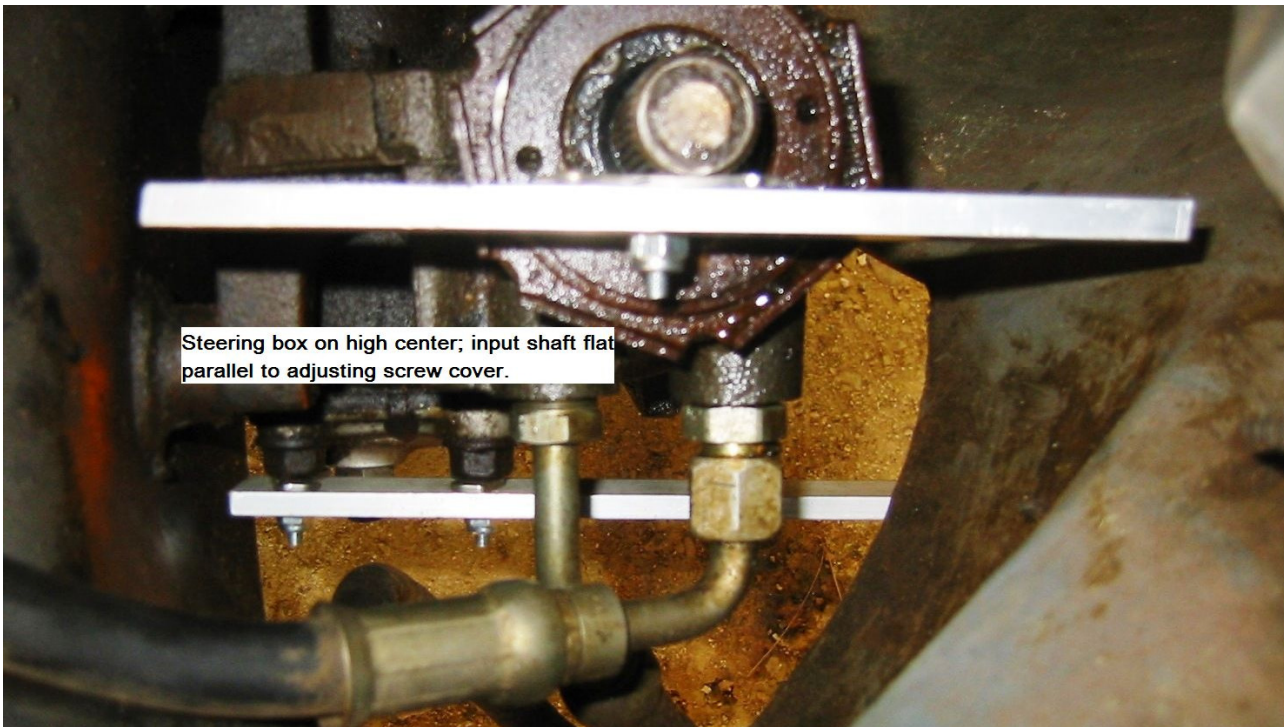
Figure 7 – Aluminum alignment strips installed

- 8) Using a 3/4 inch 12 point socket, turn the steering gear box input shaft from lock to lock counting the number of turns (usually about 3 1/3 turns).
- 9) Turn the steering gear box input shaft until it stops then turn it back one half the number of turns. This is approximately the center.
- 10) Put an aluminum strip with two magnets attached to the bolts that retain the pitman shaft adjustment cover.
- 11) Put an aluminum strip with one magnet on the steering gear input shaft and adjust the shaft until both aluminum strips are parallel.

- 12) Remove the aluminum strips and carefully install the Yoke (10) on the steering gear box input spline WITHOUT turning the input spline! Be advised it IS possible to install the Yoke (10) as many as three splines off which will inhibit proper clamping.

- 13) To verify the Yoke (10) is installed properly insert the shank end of a 29/64th drill into the Yoke (10) clamping bolt hole WITHOUT turning the Yoke (10). If it will pass through both bolt holes the Yoke (10) is installed correctly on the steering gear box input spline.

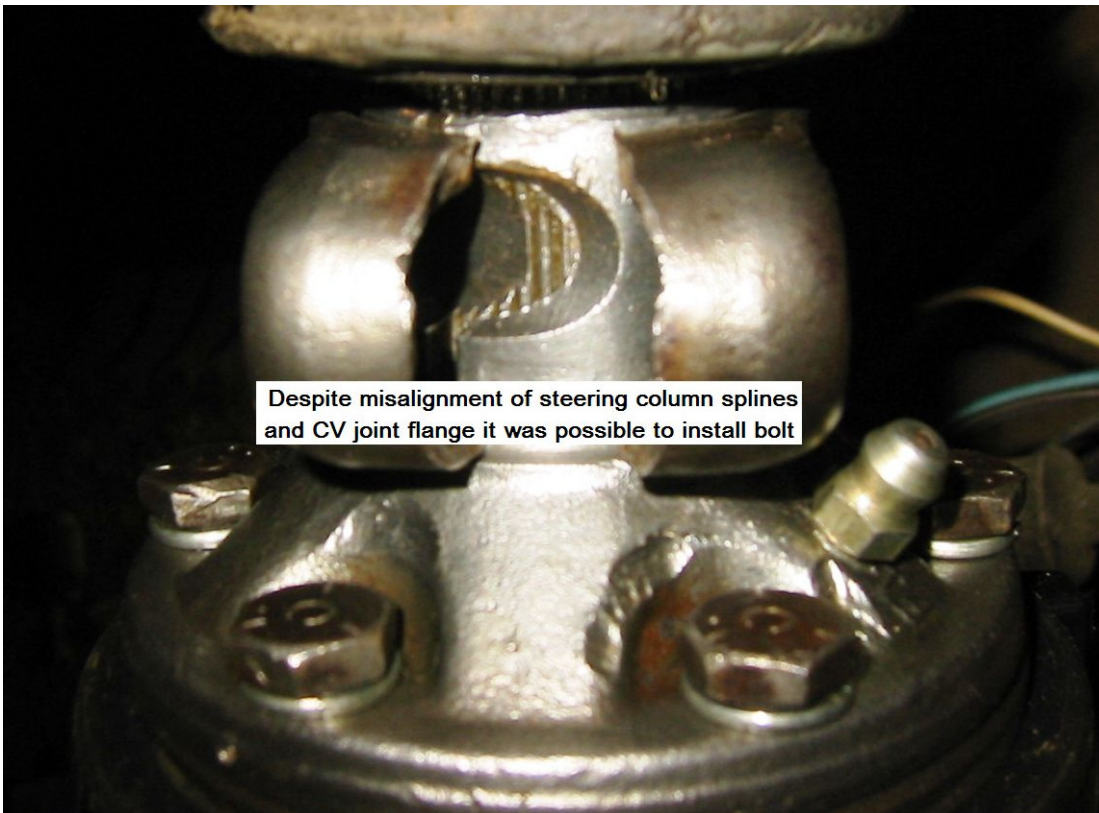
Figure 8 – Steering column / Flange (7) allowable misalignment

18) The splines on the steering column and lower steering shaft Flange (7) can be mis-aligned about three splines and it will still be possible to install the bolt through clamp and the undercut on the steering column shaft (see photo below).

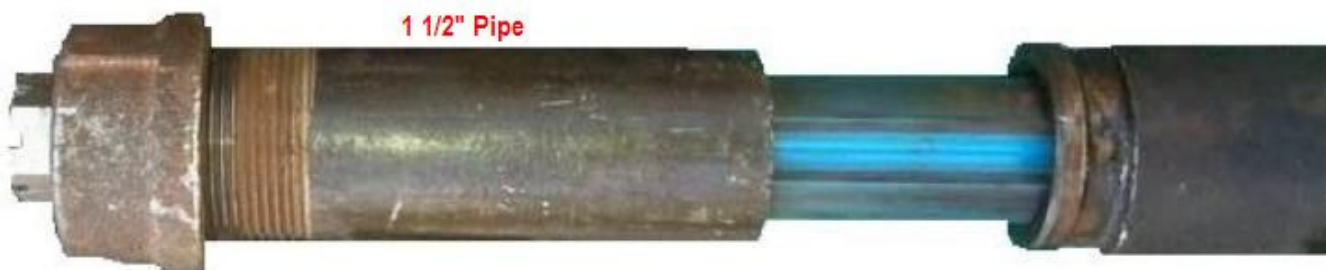
Figure A-1- Splined Shaft Removal Tool

- 14) If the Splined Shaft (1) cannot be pulled out after several days of soaking it with penetrating fluid manufacture a tool as pictured below from black or galvanized 1 1/2" pipe and cap.

- 15) Measure and record the distance from the bottom of the threaded section on the Splined Shaft (1) to where it enters the yoke

- 16) Drill a 7/16 inch hole in the pipe cap
- 17) Lubricate the cap and pipe threads with moly grease and screw the cap onto the pipe finger tight.
- 18) Cut the pipe / cap to the dimension recorded in step 15) above.
- 19) De-burr the pipe internally and externally
- 20) Lubricate the ID of the pipe and OD of the Splined Shaft (1) with Moly grease
- 21) Slip the pipe and cap over the Splined Shaft (1) and tighten the Nut (5) on the spline shaft exposed threads
- 22) Clamp the cap in a vice and using a pipe wrench unscrew the pipe from the cap
- 23) You may need to remove the pipe and cap tool and insert some 1 1/2" ID spacers to pull the Splined Shaft (1) out of the Yoke (10) far enough to be able to pull it by hand.
- 24) Do not disassemble the Universal Joint
